Daniel A. Freer
Cape Fear Service trip Report
6-10-02 thru 6-14-02

Oak Island Shore Station

Bald Head Shore Station

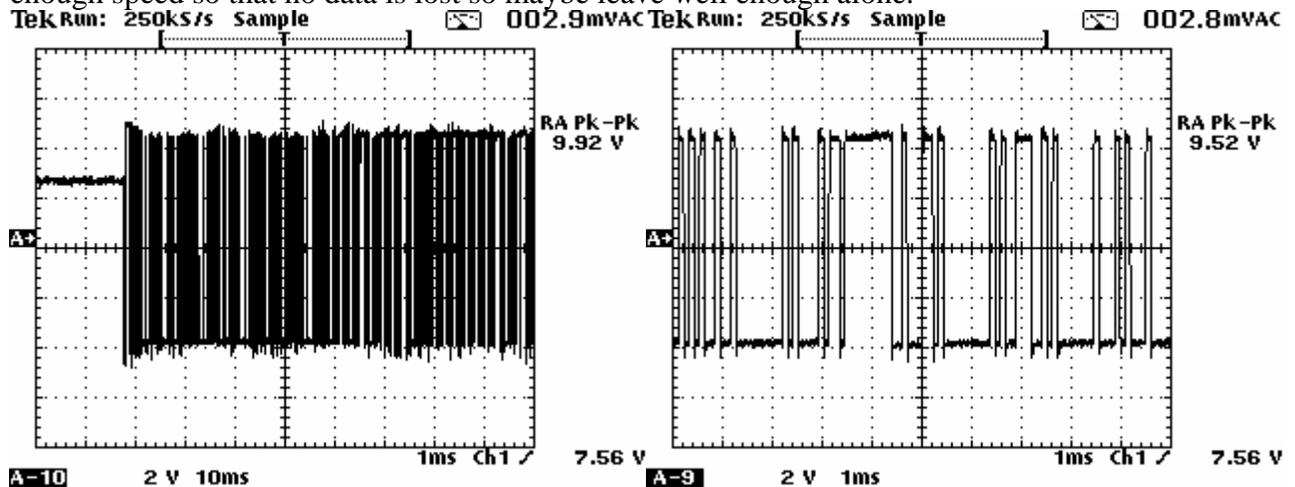
Junction box had missing and incorrect transorbs, causing some strange voltage variations when ADCP was transmitting. I.e. PWR+ to PWR- = +49.9vdc, PWR+ to COM RTN = 26 to 30 VDC, PWR- to COM RTN = -19 to 22vdc. Changed transorbs as per new Bald Head wiring diagram, and now PWR+ to PWR- = +49.9, PWR+ to COM RTN = 47.1, PWR- to COM RTN = -1.07.

Comments: This RS-422 communication link is set to 4800 baud because higher speeds caused communication errors. After replacing the transorbs the RS-422 signal looks very healthy, see scope picture below, so when time permits we could try faster interface speeds. However 4800 does give enough speed so that no data is lost so maybe leave well enough alone.

Figure 1, Bald Head RS-422 from ADCP TD+ base

Figure 2, Bald Head RS-422 ADCP TD at 1msec time

(center gradical is Ground baseline)

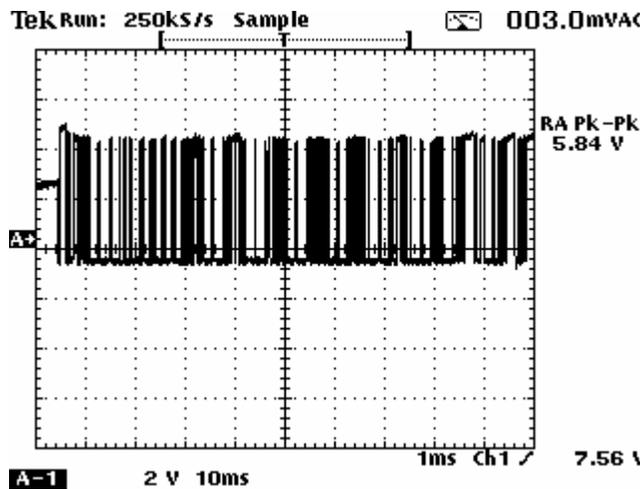
Figure 3, Oak Island RS-422 signal from ADCP

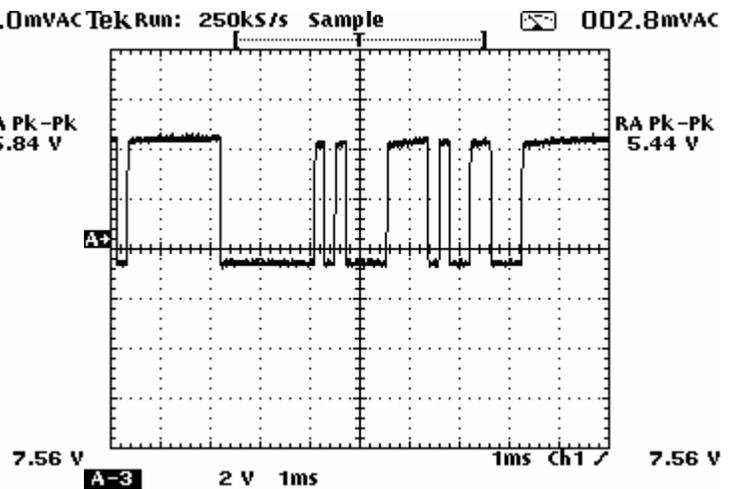
Figure 4, Oak Island RS-422 signal from ADCP 1msec

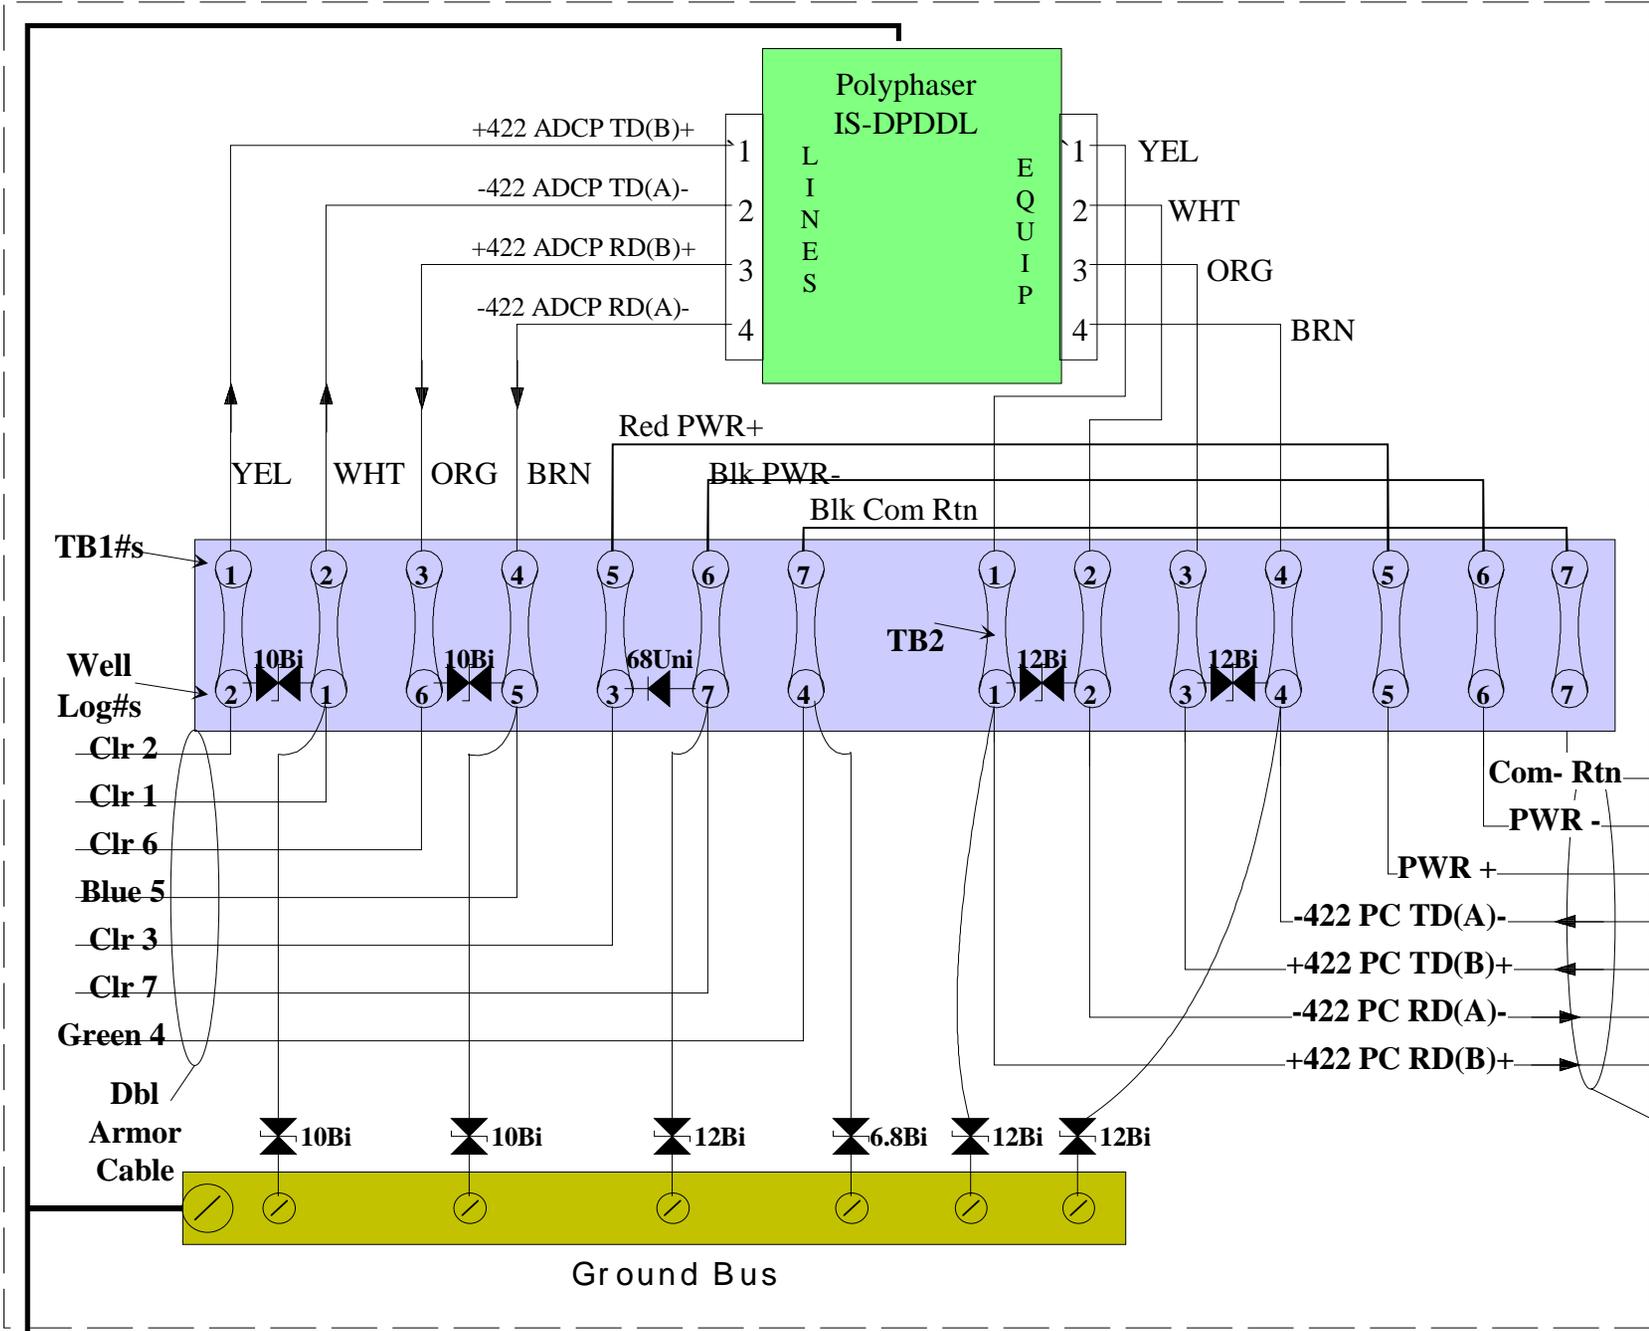
Oak Island Shore Junction Box

Familiarization with IBM computer, modem, UPS, Power supply, Dehumidifier, and Junction box. Since the unit had previously been disabled by lightning and the RS-422 board replaced in the PC, I checked out the transorbs and polyphaser. Everything checked out good, but I was concerned that the SO cable that runs from the junction box down to the PC tub runs right across the armor cable. I added some transorbs on the SO cable side of the terminal box (see new Oak Island junction box wiring diagram). Also the existing transorbs were replaced with those indicated in the new drawing.

1. Reroute the SO cable so it doesn't touch and cut right across the armor cable.
2. Measure PWR+ to PWR- and to Com RTN, Measure these points to armor. Compare with Bald head. Measure while instrument is sending data.
3. Post new wiring diagram on inside of junction box
