Trip Objectives:/Accomplishments = (√) Not Done = (°)

Summary:

Chronological Details (All times are East Coast DST)(Subtract 1 hour to get EST)

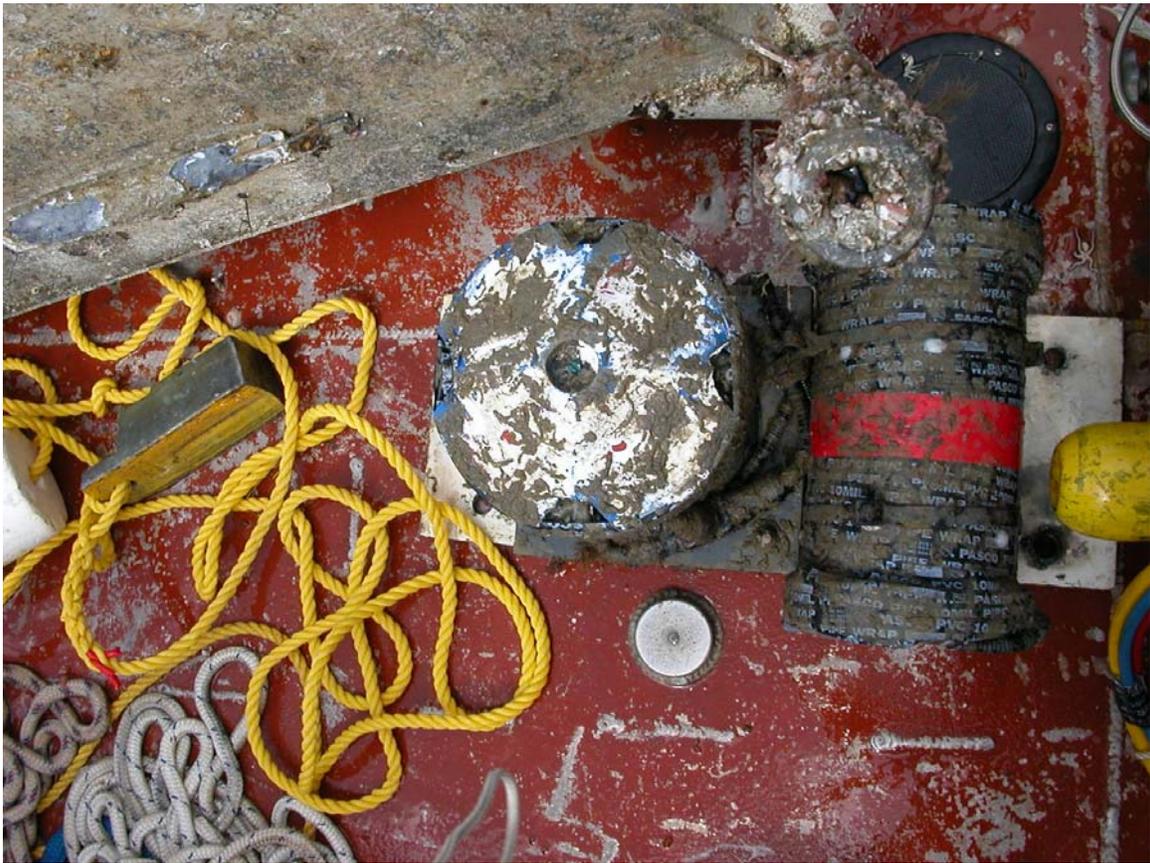
Recovered Bald Head ADCP, Destin still on transducer faces is a good antifoulant

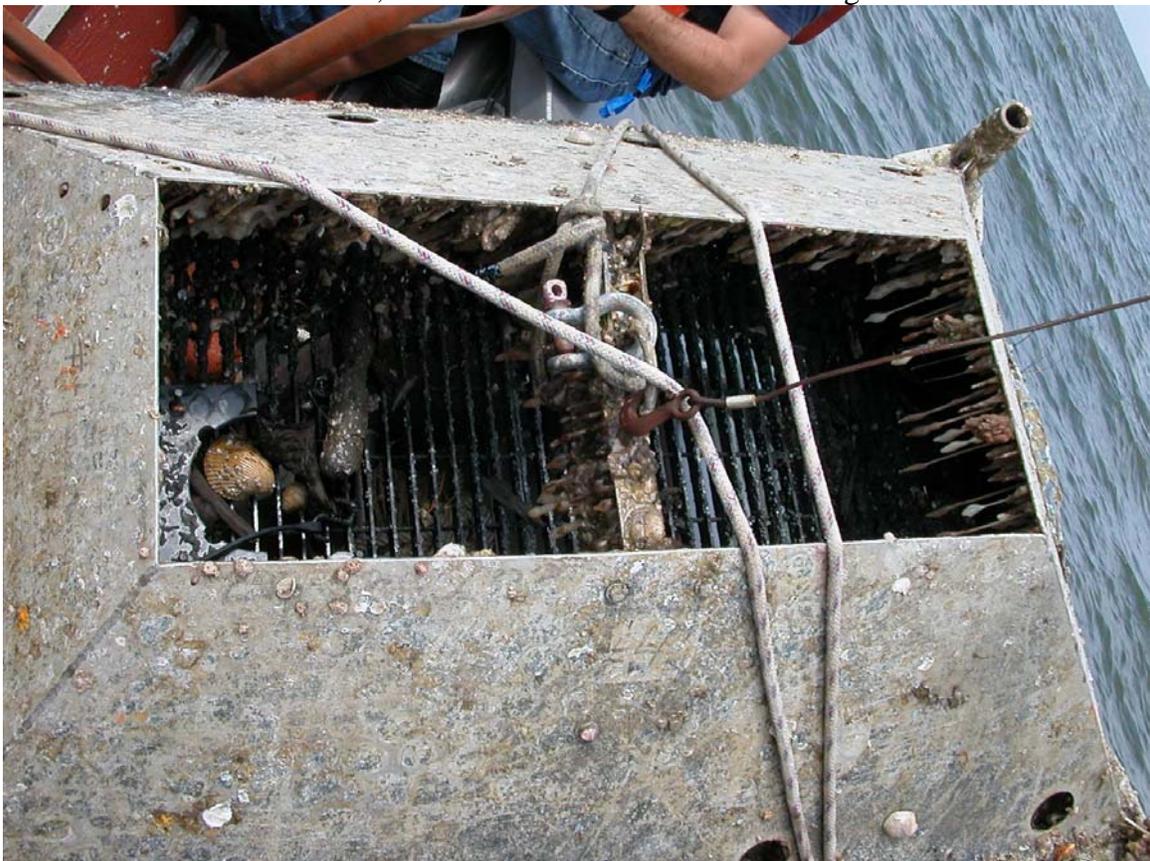
Recovered old EL pod hoisted onto dive boat
